# Wills Wing Safety Bulletin

SB20251002

**Special Attention to the placement of the basetube into the corner bracket so that the holes line up and bolt is inserted through both components**

Wills Wing Alpha's, Falcon 3-4's s and Falcon 3-4's Tandem

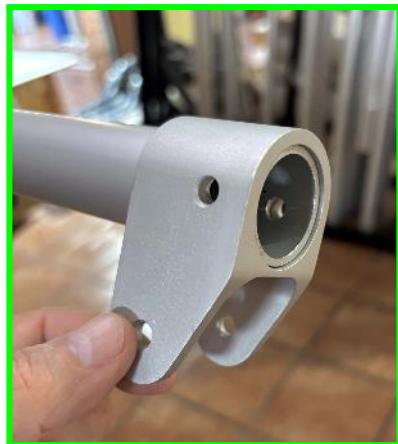
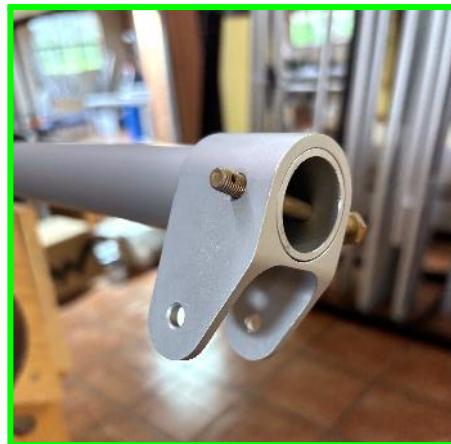
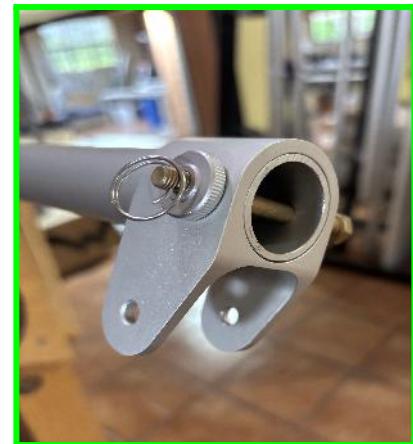
The photos below with a green solid edge show the correct way to assemble the base bar to the corner bracket.

When the basetube is inserted into the corner bracket, it is vital that the holes in both components **are aligned** before placing the bolt, and the bolt is inserted through **both** components (base bar and corner bracket) and secured by nut and safety ring. Failure to make the connection on both sides of the base tube in this way will render the glider not fit for flight. If this connection is not secured, the glider is not airworthy and a structural failure is likely.

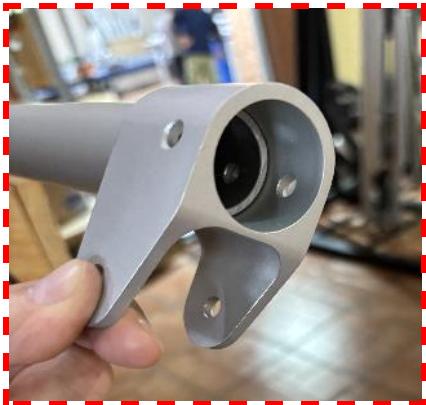
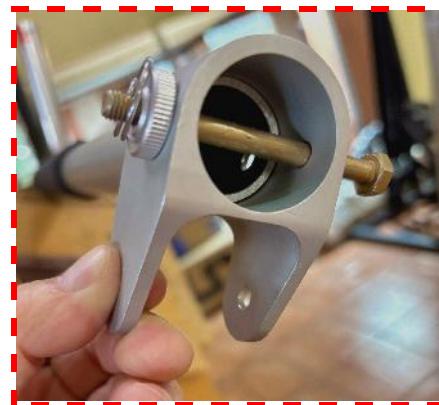
The pictures below with a red hatched edge illustrate one way in which an error can be made. This is a critical point that must be given full attention during set-up and pre-flight check, and is vital for safe flight.
